Navajo Abandoned Uranium Mine

Site Screen Report

Mine Name: Claim 28

Mine IDs: 78, 79

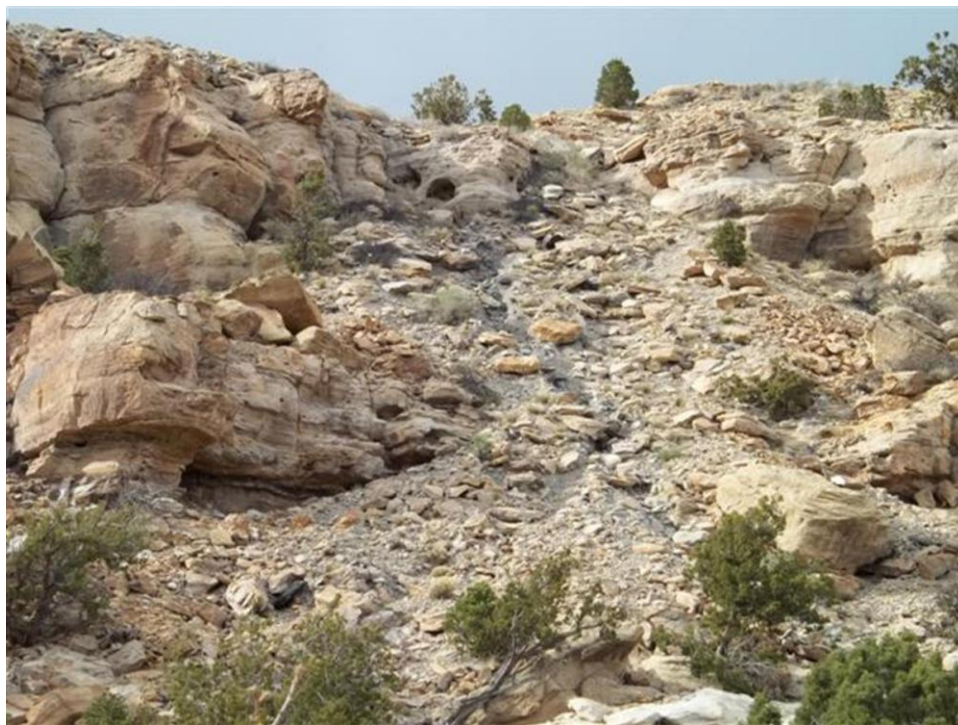
Photo 1: Mine Site #78; Potential adit with waste rock

Potential adit, covered by rock

Waste rock throughout slope/bench area, and below adit

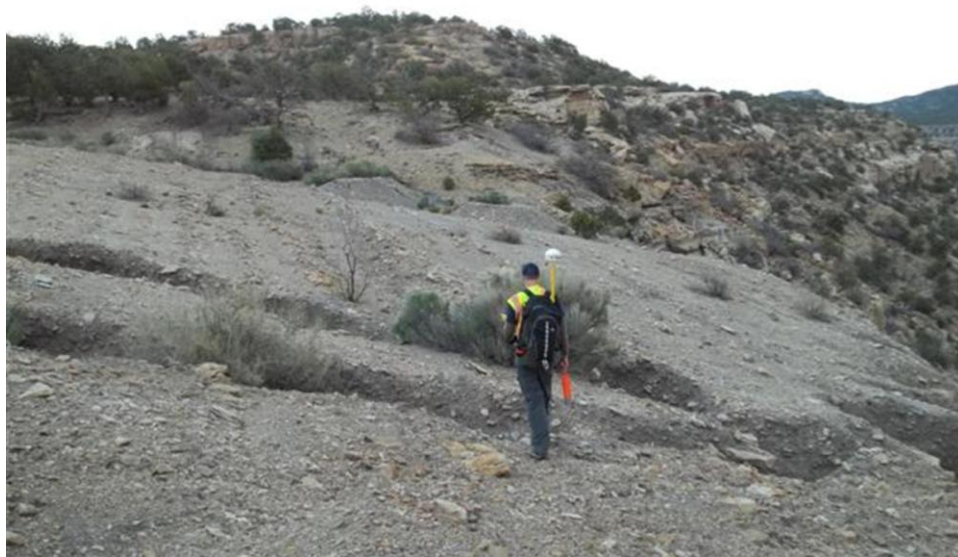
Photo 3: Mine Site #78; Top of mine

Reclamation area atop mesa; worked areas throughout site

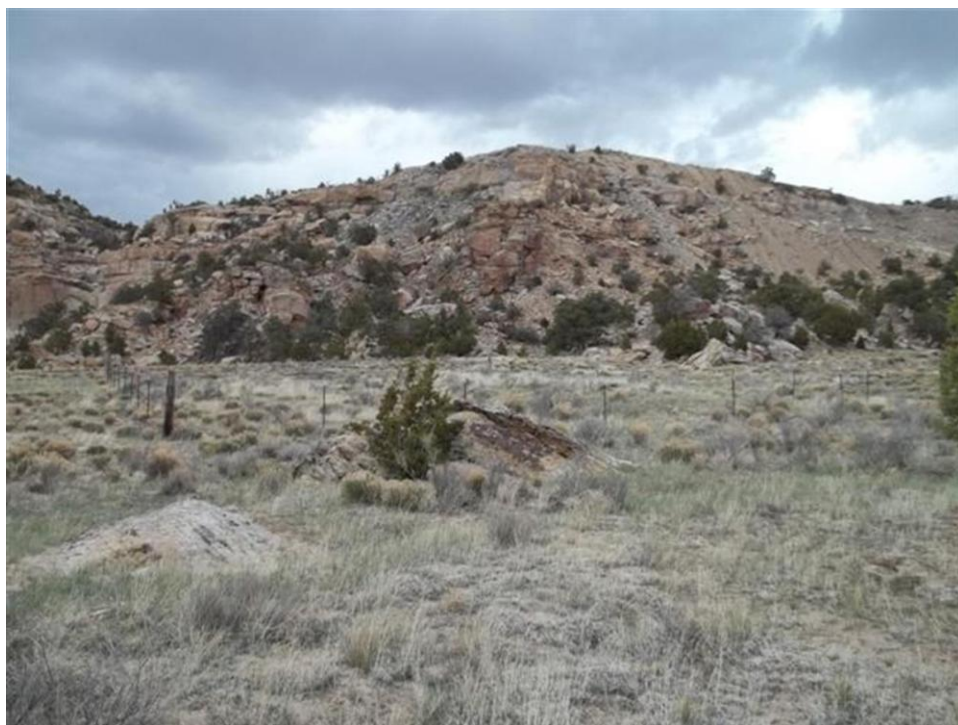
Photo 6: Mine Site #79; Fenced area

Fenced area with possible reclamation cap
